1 REPORT NO. CA-DOT-TL-3324-1-76-14		2 GOVERNMENT ACCESSION NO.		3 RECIPIENT'S CATALOG NO.	
4 TITLE AND SUBTITLE A REVIEW OF THE PERFORMANCE OF LIME TREATED ROADWAYS IN CALIFORNIA				5 REPORT DATE April 1976	
				6 PERFORMING ORGANIZATION CODE	
7 AUTHOR(S) Max L. Alexander				8 PERFORMING ORGANIZATION REPORT NO. 19303-633324	
9 PERFORMING ORGANIZATION NAME AND ADDRESS Office of Transportation Laboratory California Department of Transportation Sacramento, California 95819				10 WORK UNIT NO.	
				11 CONTRACT OR GRANT NO. D-2-14	
12 SPONSORING AGENCY NAME AND ADDRESS California Department of Transportation Sacramento, California 95807				13 TYPE OF REPORT & PERIOD COVERED Final	
				14 SPONSORING AGENCY CODE	
15 SUPPLEMENTARY NOTES This study was conducted in cooperation with the U.S. Department of Transportation, Federal Highway Administration.					
16 ABSTRACT A review was made of the pavement condition of roadways constructed with lime treated soils and aggregates throughout California. This review, in conjunction with detailed investigations of selected roadways, was used to evaluate the performance of lime treated materials when incorporated into the roadway structural section.

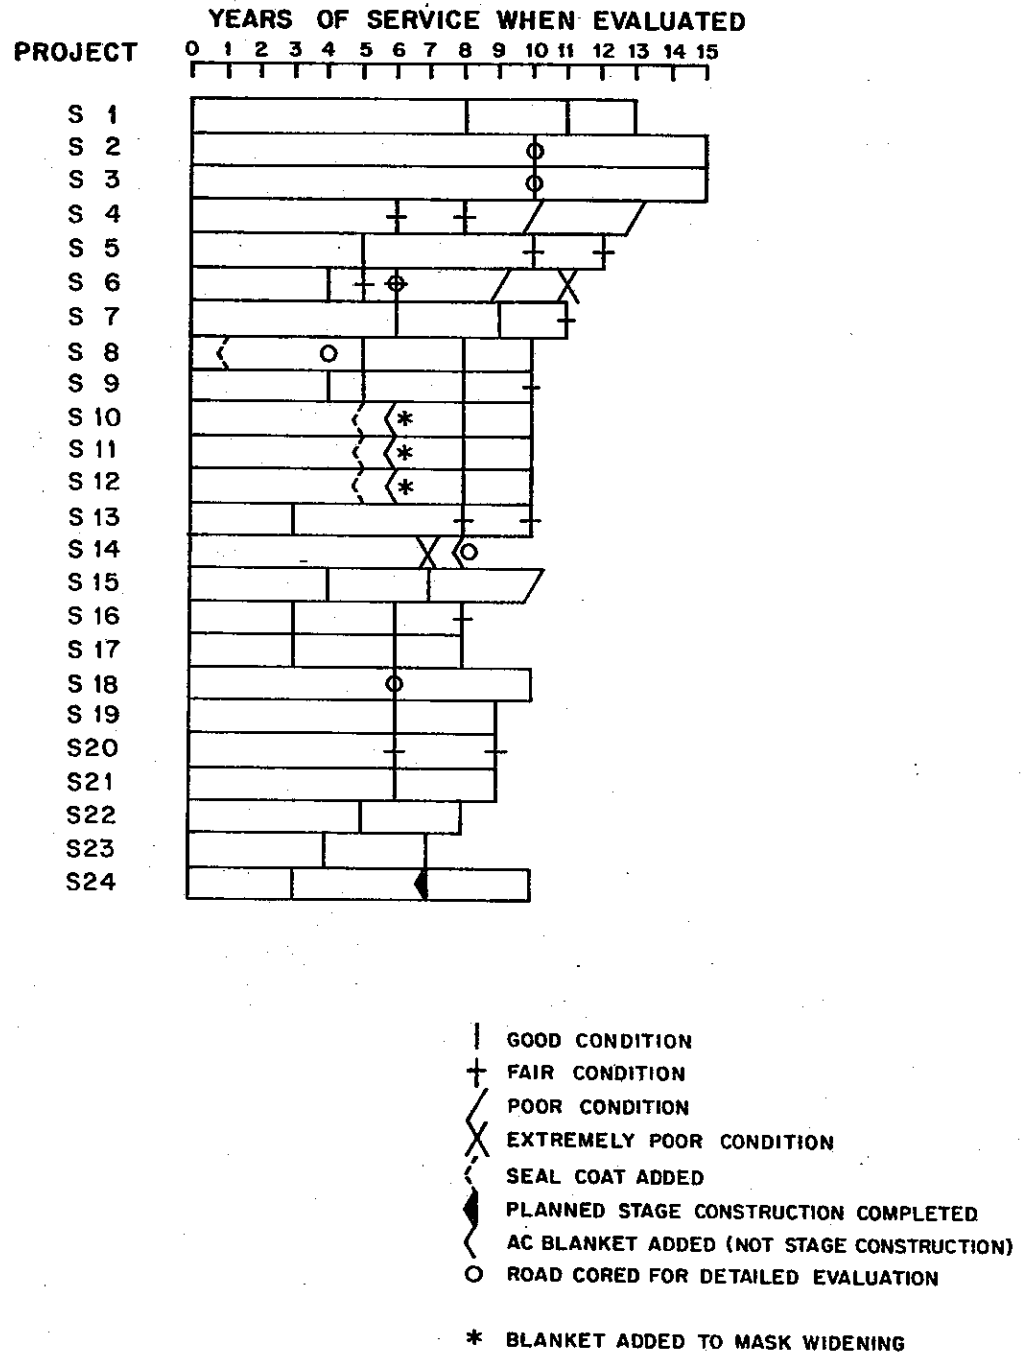
Figure 1

of service. Included in this condition survey is a list of the types of distress or cracking observed and an assigned condition rating. The surface conditions after various lengths of time in service are presented in Figure 1. The length of service time prior to resurfacing, reconstruction, or coring in conjunction with this study are also shown.

PERFORMANCE EVALUATION OF ROADWAYS INCORPORATING LIME TREATED MATERIALS AS A SUBBASE

two, one was in extremely poor condition when first reviewed after seven years of service and a new asphalt concrete surface was added one year later.

Localized distress was also observed in a few of the other roads. Although the distress was sometimes severe, the total area affected was quite small and the overall condition was rated as fair to good.

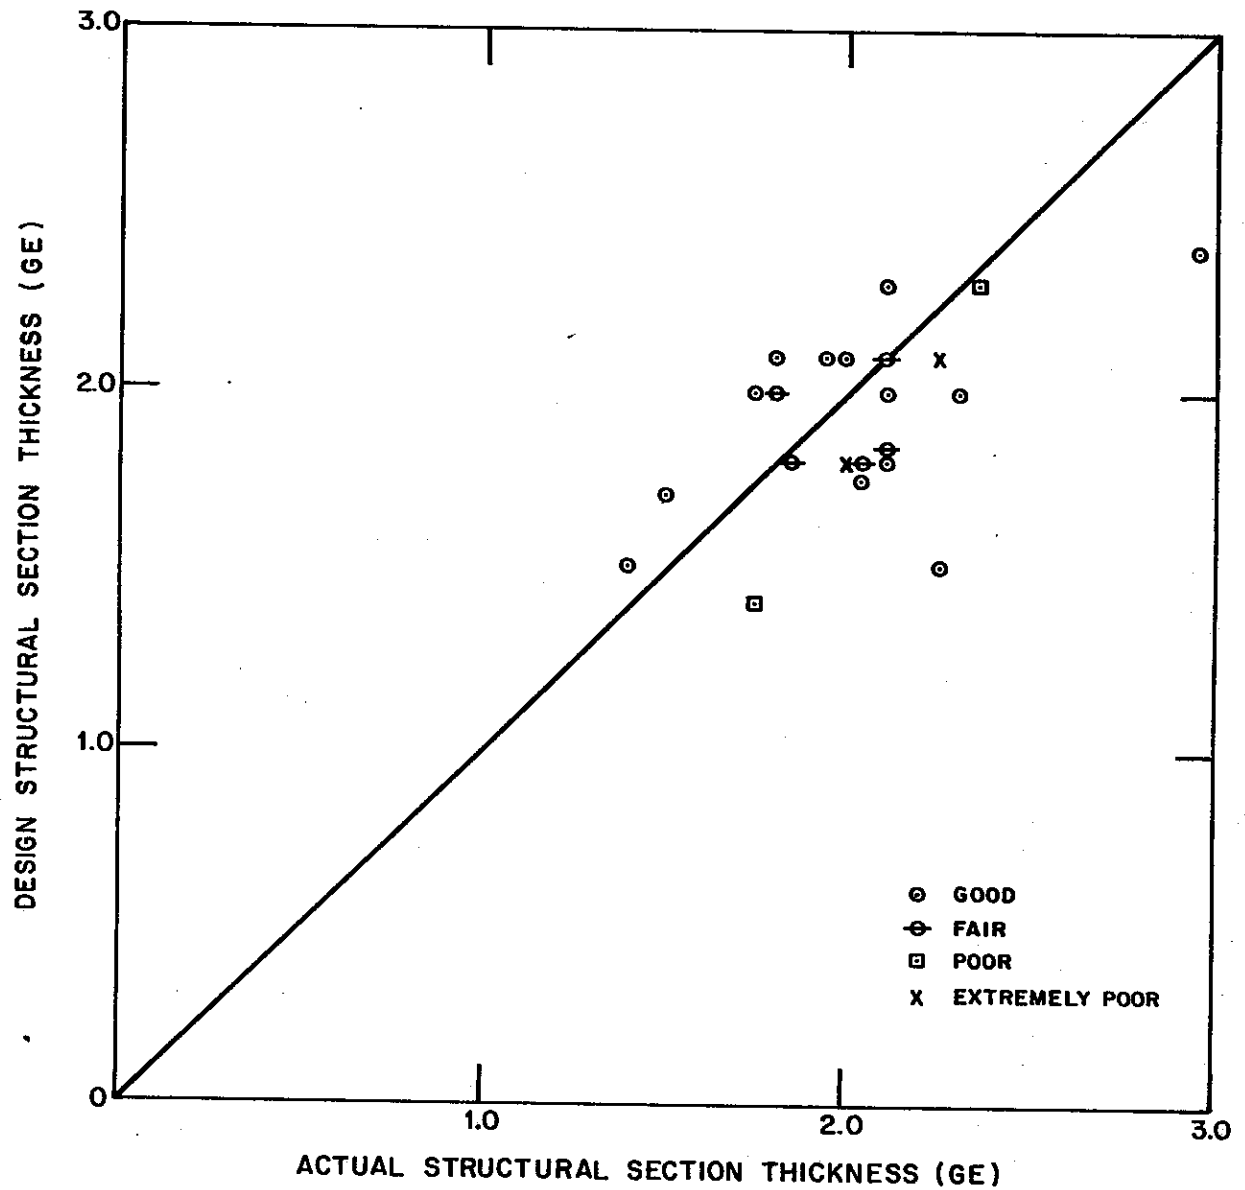
A review of the structural section data in Table 1 indicates that the actual gravel equivalent thicknesses of the 24 different roads varied from 0.3 foot less than required by the current design procedure to as much as 1.2 feet more than required. A comparison of the current design thicknesses with the actual as-built thicknesses in Figure 2 fails to show a definite correlation between the structural section and the performance rating. Each of the four roads constructed with 0.5 ft. or more thickness than required was in good condition but all of the roads which were rated as being in poor or extremely poor condition were also constructed with an "adequate" design thickness or better. Only one of the nine roads constructed with less than "adequate" total thickness was judged to be in fair condition while all of the remainder were in good condition.

**DEVIATION FROM STRUCTURAL SECTION DESIGN THICKNESS
AND THE EFFECT ON PAVEMENT PERFORMANCE
(LIME TREATED SUBBASE)**

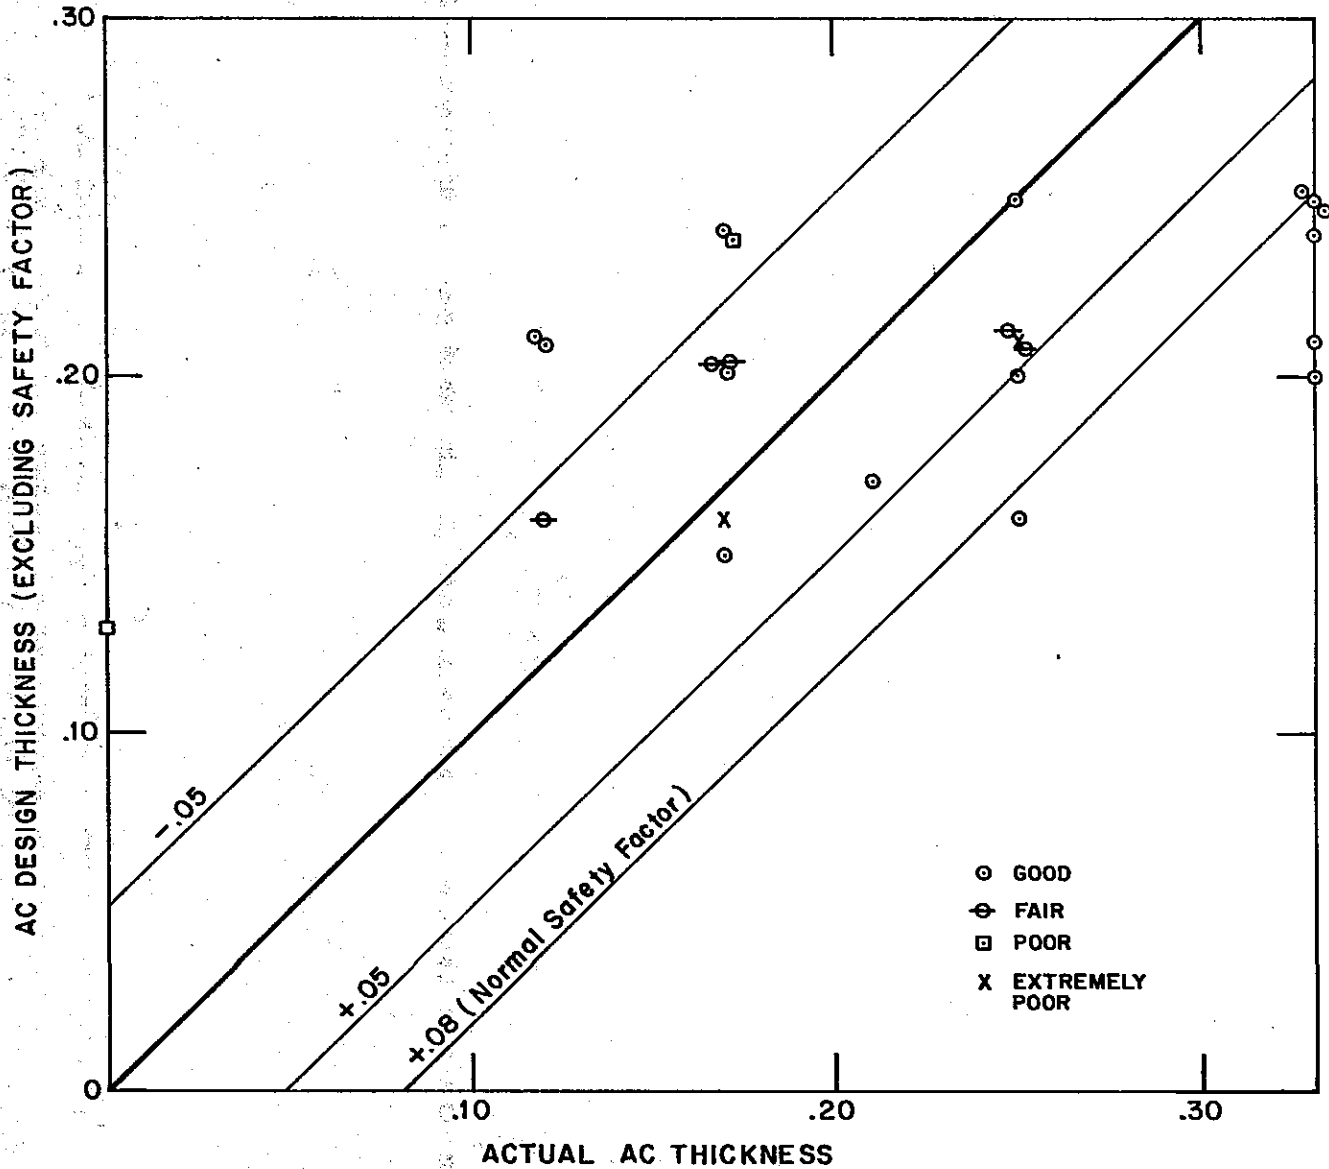
A comparison of the current thickness design requirements and as-built thicknesses of the asphalt concrete in Figure 3 shows that the performance of this group of roads is influenced to some degree by the adequacy of the surfacing. All of the roads which included the additional asphalt concrete required by the design procedure as a safety factor were in good condition. Eighty two percent of the roads which were constructed within $\pm .05$ ft. of the "design" asphalt concrete thickness were in fair to good condition while 60% of the roads which were deficient in asphalt concrete thickness by more than .05 foot were in fair to good condition.

DEVIATION FROM ASPHALT SURFACING DESIGN THICKNESS
AND THE EFFECT ON PAVEMENT PERFORMANCE
(LIME TREATED SUBBASE)

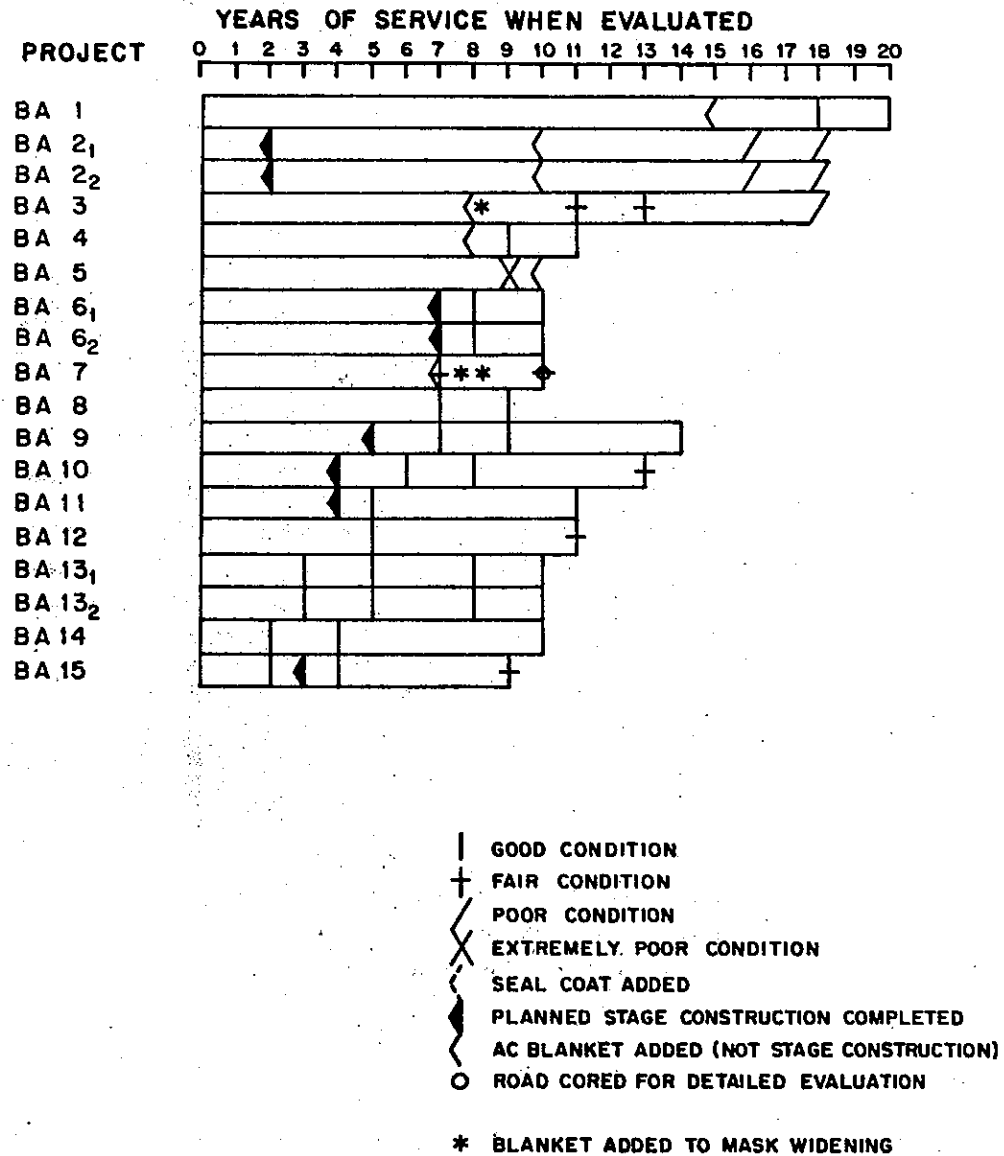
Figure 4

The design data and structural section thicknesses for the eighteen roads constructed with lime treated aggregate as a base are tabulated in Table 3. A summary of the lime treated material used on each project and an evaluation of the actual or projected surface condition of the roadway after 10 years of service are listed in Table 4. The surface conditions after various lengths of time in service are presented in Figure 4. The length of service time prior to resurfacing, reconstruction, or coring in conjunction with this study are also shown in Figure 4.

PERFORMANCE EVALUATION OF ROADWAYS INCORPORATING LIME TREATED AGGREGATES AS A BASE

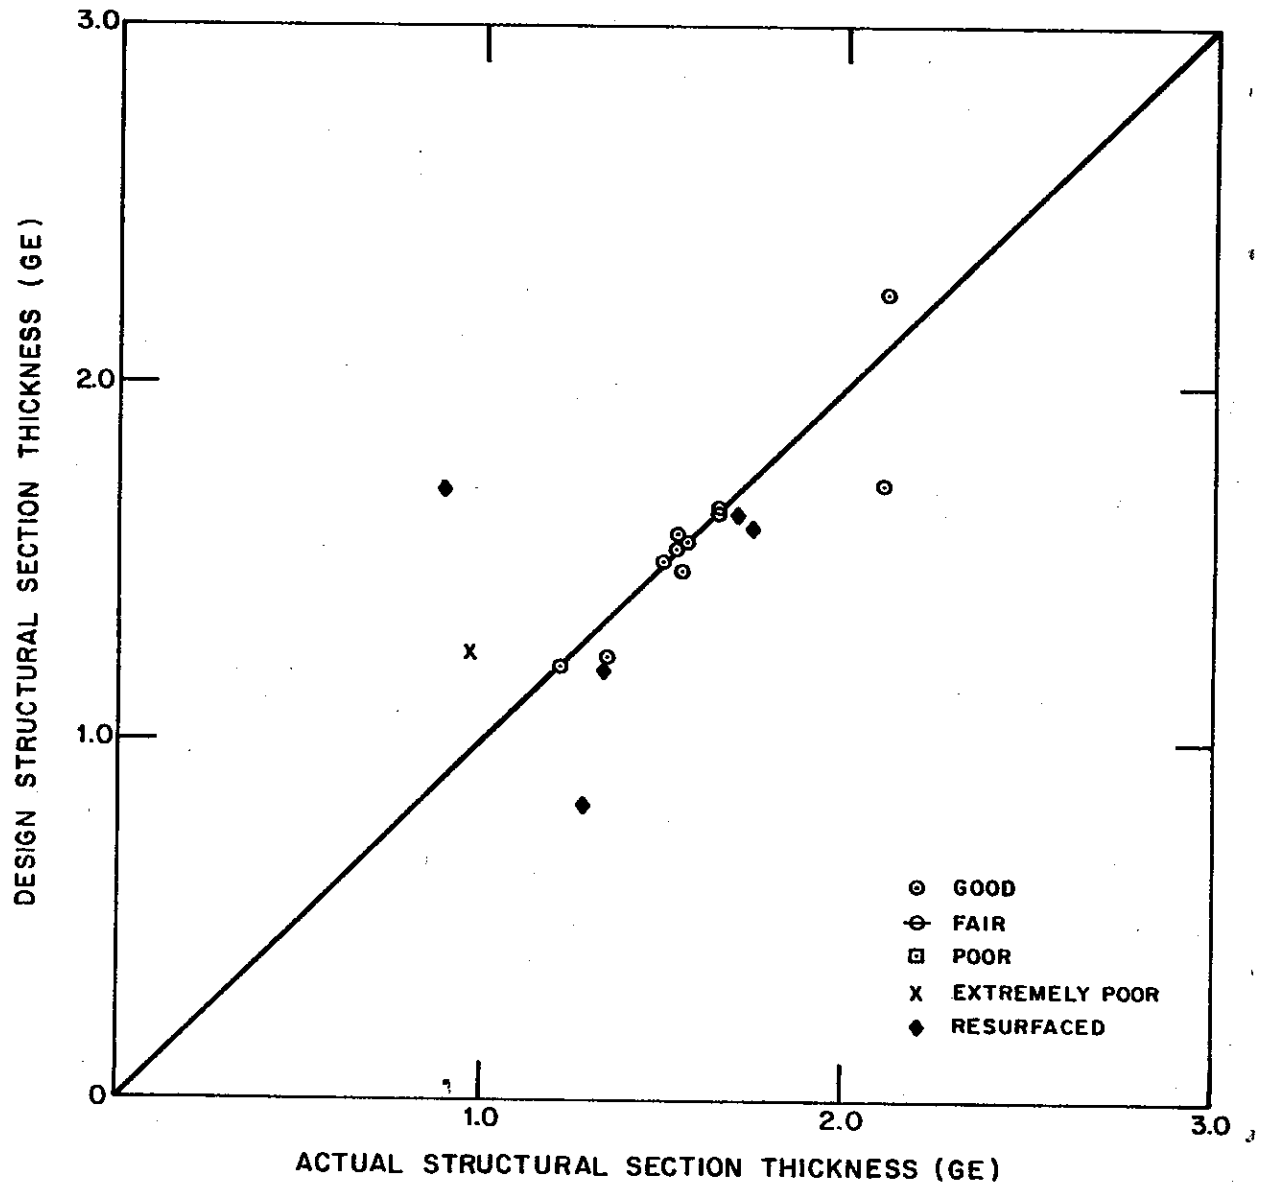
Figure 5

Comparisons of the design structural section thicknesses with the as-built thicknesses are presented in Figure 5. Only three roads were deficient in total structural section thickness. It was one of these structurally deficient roads which was found to be in extremely poor condition after nine years of service.

DEVIATION FROM STRUCTURAL SECTION DESIGN THICKNESS
AND THE EFFECT ON PAVEMENT PERFORMANCE
(LIME TREATED AGGREGATE BASE)

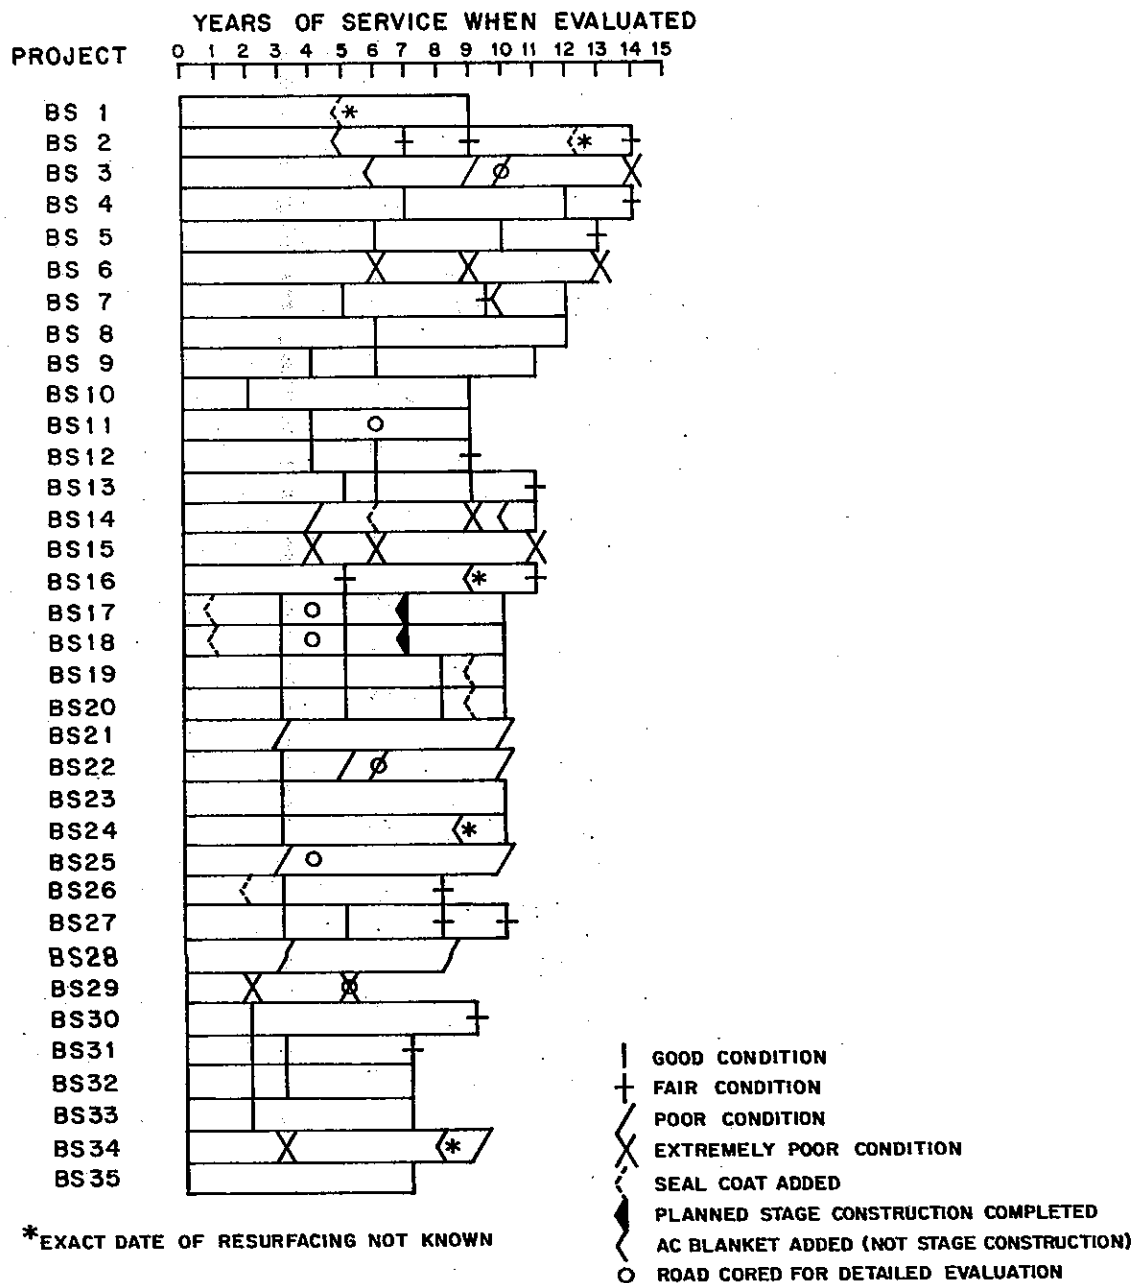
Figure 7

The design data and structural section thicknesses for this group of roads are tabulated in Table 5. A summary of the lime treated material used on each project and an evaluation of the actual or projected surface condition of the roadway after 10 years of service are listed in Table 6. The surface conditions after various lengths of time in service, along with the length of service time prior to resurfacing, reconstruction, or coring are presented in Figure 7.

PERFORMANCE EVALUATION OF ROADWAYS INCORPORATING LIME TREATED SOILS AS A BASE

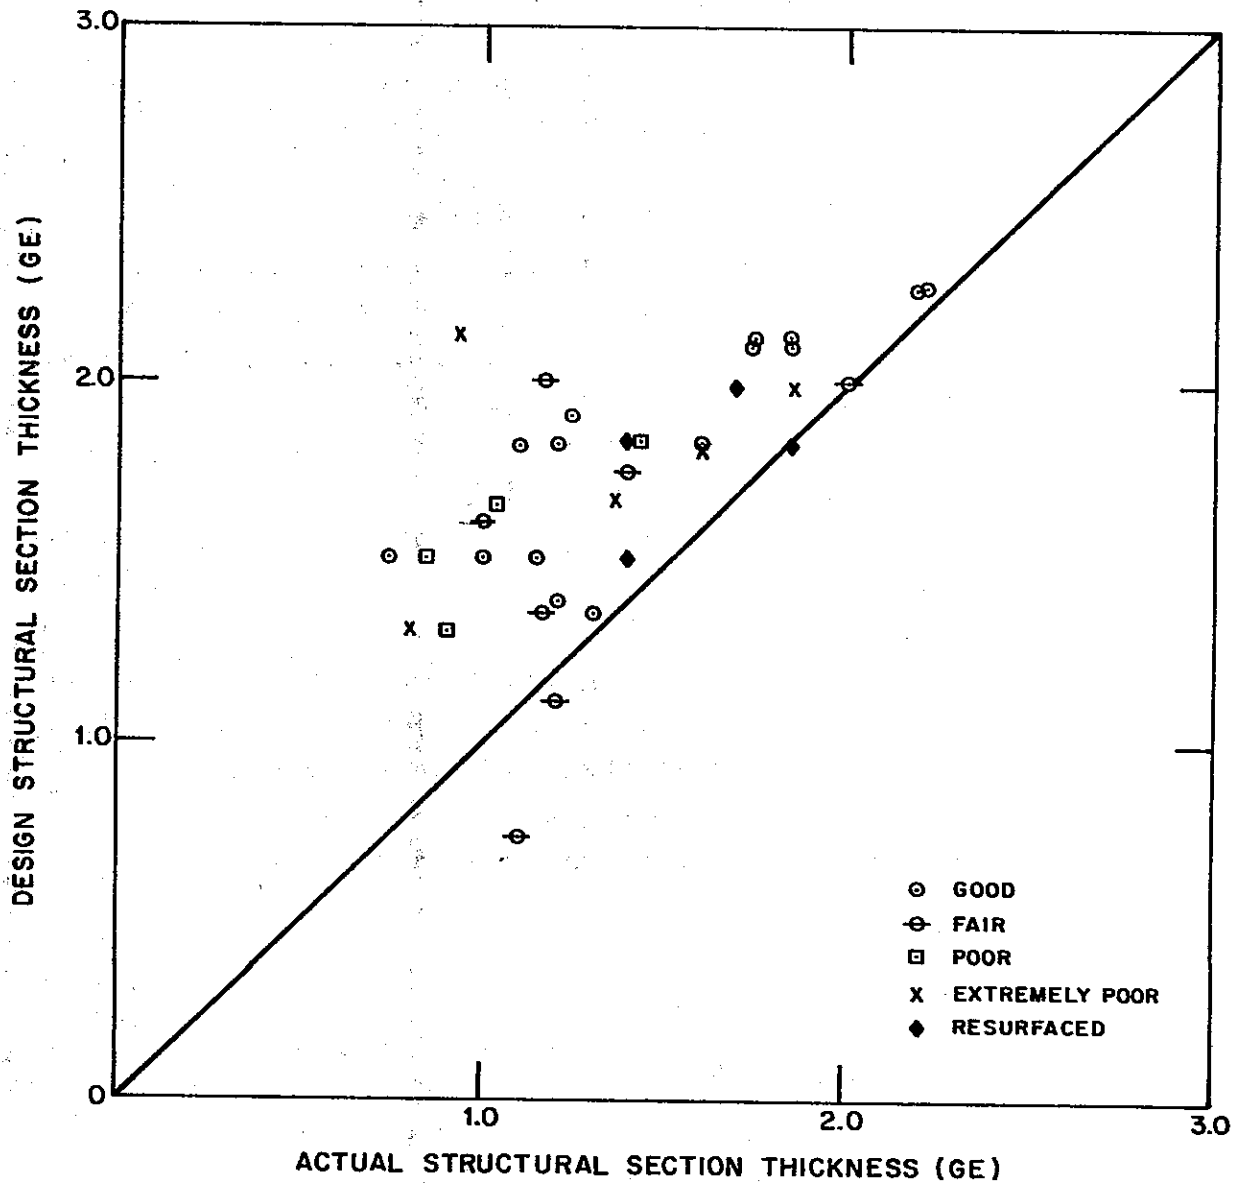
Comparisons of the required (by design criteria) and actual total gravel equivalent thickness and asphalt concrete surfacing thicknesses are presented in Figure 8 and 9 respectively. Based on Figure 8, there is little correlation between road performance and deficiency of the gravel equivalence of the total structural section. Many roads were found to be in good condition even though deficient by up to 0.75 foot in gravel equivalence. Others had been resurfaced or were in various stages of distress even though the constructed section was adequate or only slightly deficient according to the design formula.

DEVIATION FROM STRUCTURAL SECTION DESIGN THICKNESS
AND THE EFFECT ON PAVEMENT PERFORMANCE
(LIME TREATED SOIL BASE)

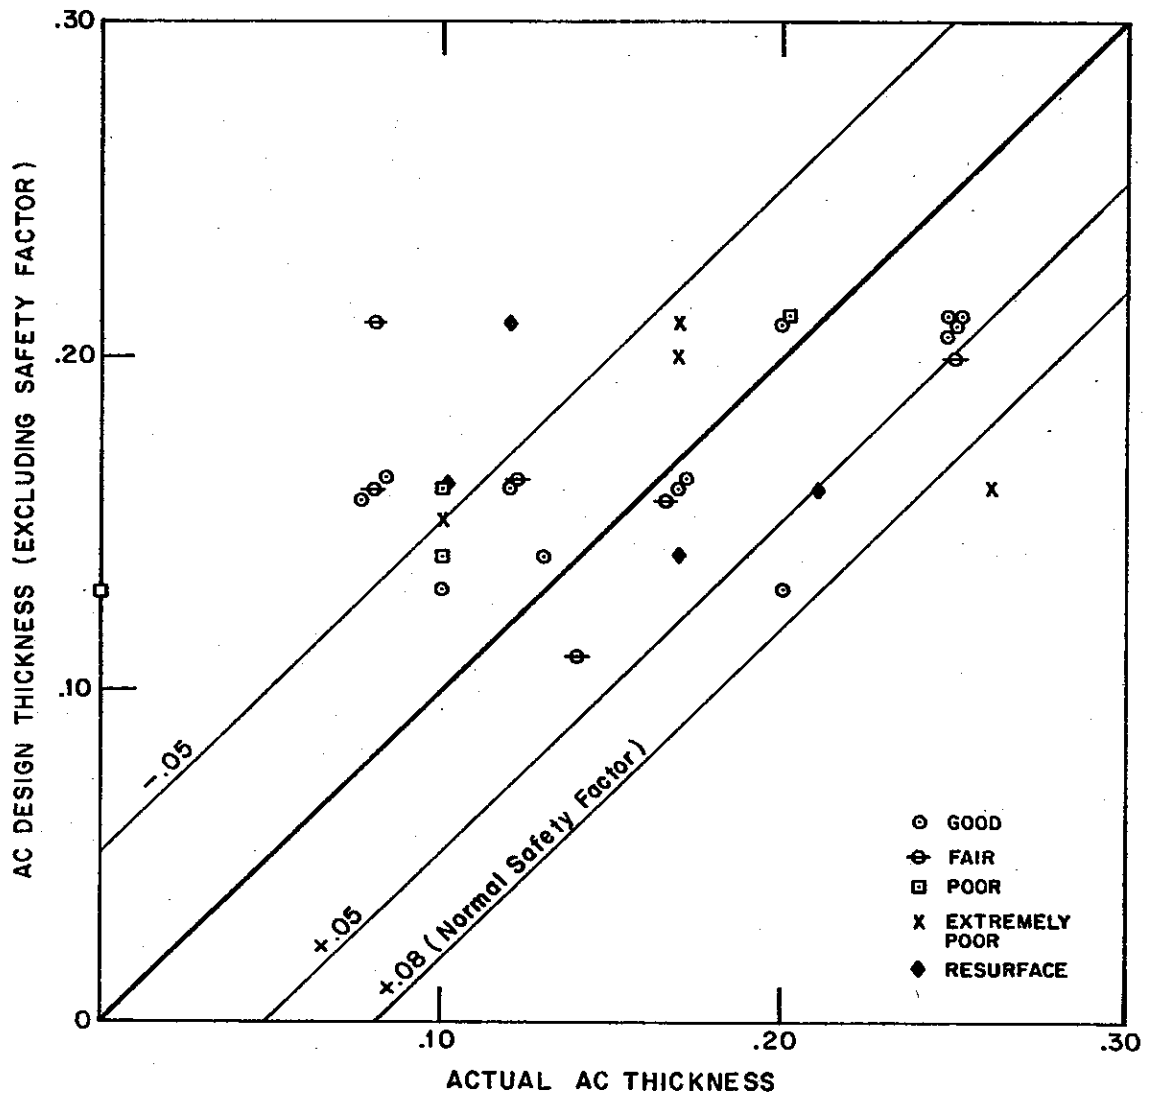
Figure 9

Figure 9, however, indicates once again that there is a correlation between performance and deficiency in the asphalt concrete thickness. Eighty percent of the roads which were constructed with asphalt concrete surfacing equal to or exceeding the design requirement were in fair to good condition after 10 years. Fifty-five percent of the roads which were deficient by no more than .05 ft. were in fair to good condition while only 45 percent of the roads which were deficient by more than .05 ft. remained in fair to good condition.

**DEVIATION FROM ASPHALT SURFACING DESIGN THICKNESS
AND THE EFFECT ON PAVEMENT PERFORMANCE
(LIME TREATED SOIL BASE)**

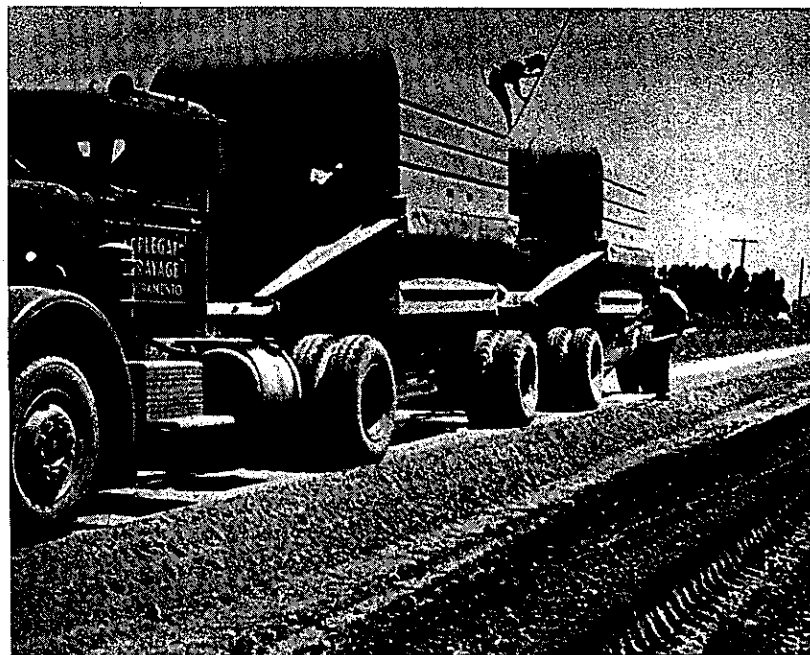
Bulk lime soon replaced the bagged lime but uniform distribution over the roadway or in a windrow proved to be a difficult problem. Cement distributor trucks, bottom dump trucks with drag type spreader boxes, and screw fed vane type distributor hoppers were tried, but great difficulty in applying the lime at a uniform rate was experienced with all of them. The finely ground lime bridged the openings and would not flow at all or flowed so freely that it could not be controlled. On one job, workmen were required to walk along side the bottom dump transport trucks and pound the sides with rubber mallets while another man poked the lime down from the top using a long rod (see Figure 12.)

Figure 12
Assisting Lime Discharge From Transport - Distributor

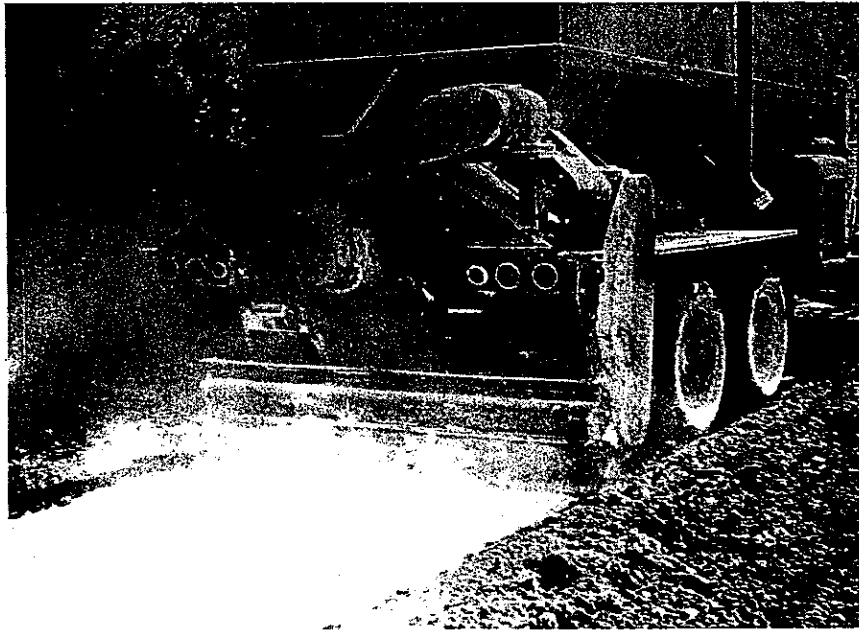
As the use of lime increased, most of the work was taken by specialized contractors and specially designed spreading equipment was developed (see Figure 13). Vibrators and circulation systems built into the spreaders helped alleviate much of the difficulty in distributing the bulk lime. With the increase in acceptability of granular quicklimes during the past few years, the problem of distribution has been reduced even further. Some agencies have found that the uniformly graded granular quicklimes can be spread with sufficient uniformity by tailgating from an end dump truck.

Figure 13
Distributor Truck With Vibrator and Recirculation System

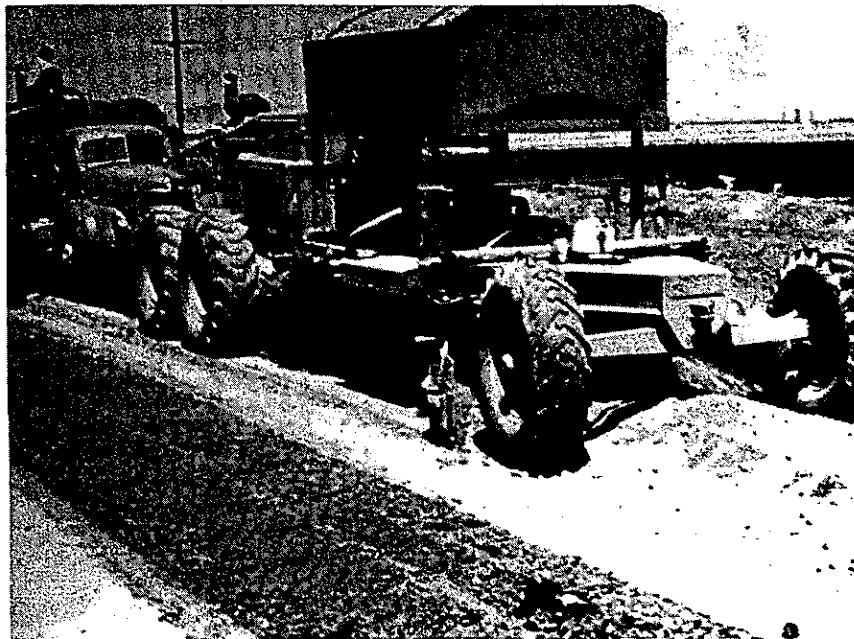
Pug mill type mixers (see Figure 14) were found to be satisfactory for mixing loose granular materials but they were totally useless for mixing heavy clay materials. In some instances the soils built up on the paddles and in the drum of the pug mill until it was completely clogged. Tractor mounted, cross shaft, rototiller type mixers (see Figure 15) soon proved their effectiveness in mixing lime with the finer grained materials, including heavy gumbo clays. The smaller farm type tillers were sometimes incapable of maintaining uniform depth control but several manufacturers have developed large towed or self-propelled mixers which are very effective for mixing lime with the soil and at the same time adding controlled amounts of water. Problems with depth control have also been virtually eliminated.

Figure 14
Pug Mill Type Mixer

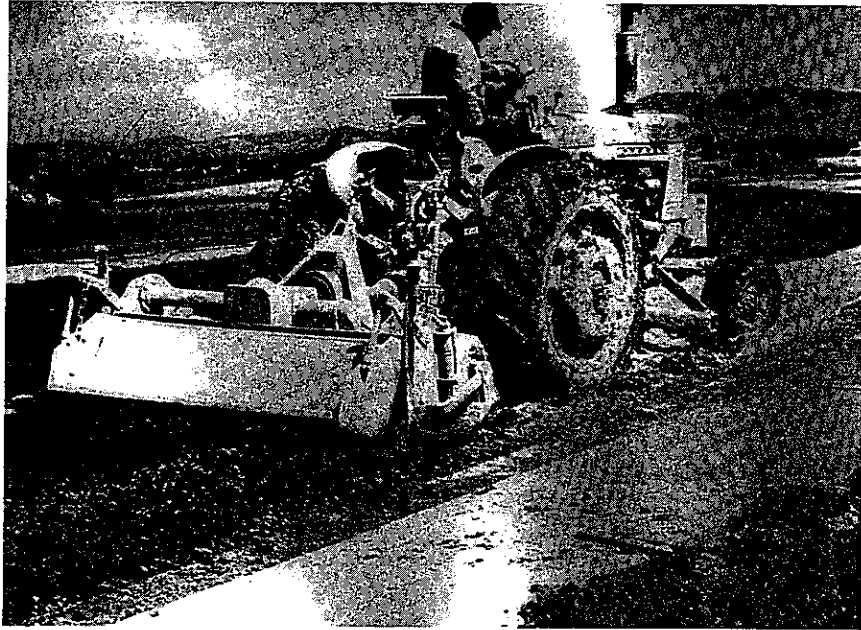
Figure 15
Tractor Mounted Rototiller

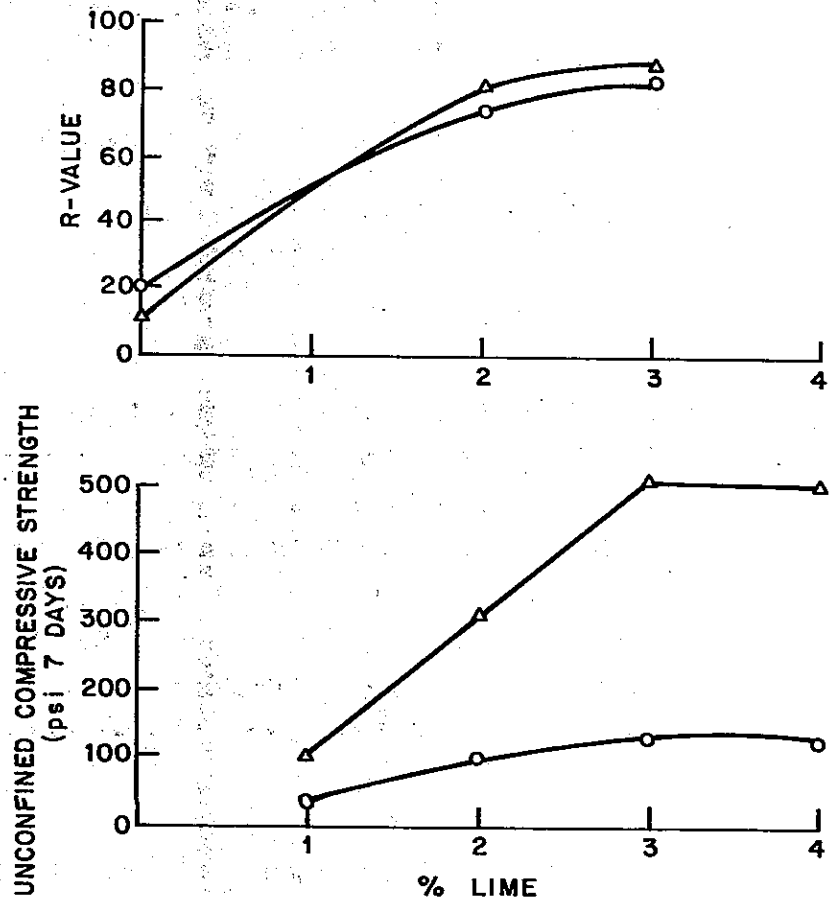
Figure 19

typified by the two sets of data plotted in Figure 19. Both soils achieved approximately the same R-value when equal amounts of lime were added. Unconfined compressive strengths for these same two soils are also plotted in Figure 19. Quite obviously, the cementing action was much greater with the one soil than with the other.

**A COMPARISON OF THE EFFECT OF LIME TREATMENT
ON THE R-VALUE AND COMPRESSIVE STRENGTHS
OF TWO TYPICAL SOILS**
